# Report for the Conservation of the Cromarty East Church Funerary Hatchment

Historic Scotland Conservation contract  
2007 - 2010

HS/C/53496/3500

**AOC Project No:** 21214\_2

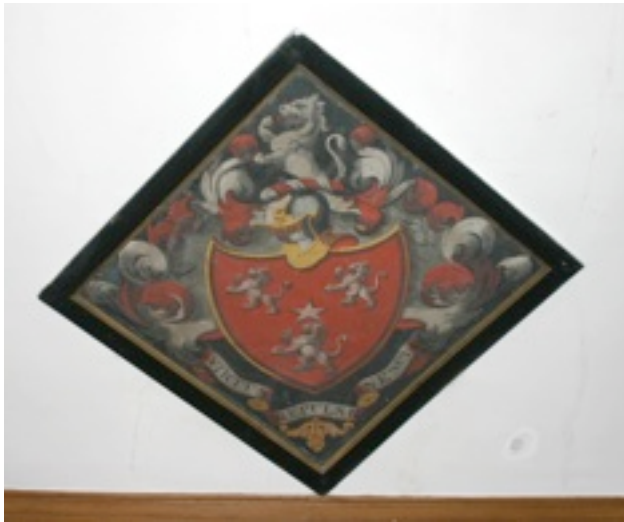
The hatchment was suffering from surface and environmental pollutants, water damage from the high humidity, flaking paint, cracking and multiple holes were observed on the canvas. The canvas has bowed due to its location in the church and the weight of the canvas. This has happened over time as the hatchment is traditionally used outside the church during the funeral or hanging in the family home before its hanging in the church.

*Figure 1: Funerary hatchment in-situ*

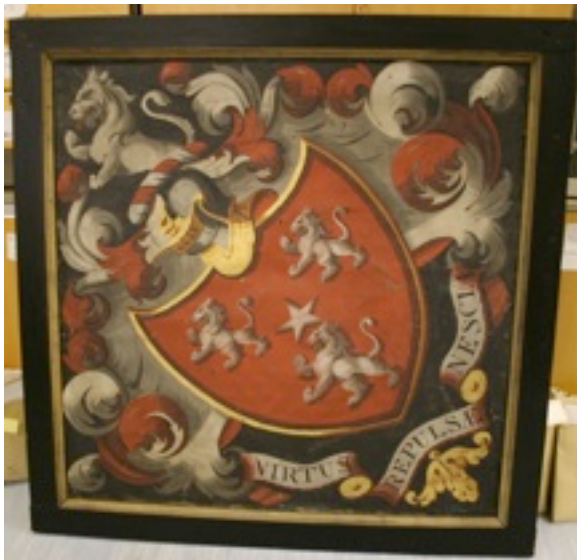
*Figure 2: Funerary hatchment front after*

The hatchment has been cleaned with mineral solvents and the fragile pigments were consolidated with BEVA 371, this ensured the long-term aging stability of hatchment it also bound the pigments to the substrate fully also further strengthening the canvas back.

The weight of the pigments had begun to stretch the canvas, to correct the problem the hatchment was put under small weights while it was being solvent cleaned. This was effective in relaxing the canvas and the weights allowed the canvas to be moulded back into its original shape, 3mm netting was then used to help support the canvas in the frame, where the canvas has holes invisible nylon thread was secure the net to the canvas giving it further support. The canvas was not tightened back fully as this allow the hatchment to rest once re-hung without putting unneeded pressure on the canvas.

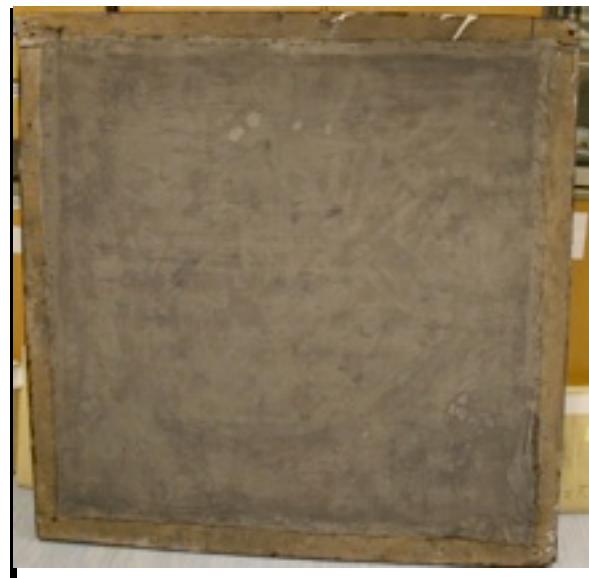
*Figure 3: Funerary hatchment back after*
